U.S. Geological Survey

OPEN FILE MAP 79-1314 (F-4)

COLLUVIAL SLOPES WITH LANDSLIDES Landslides too small or obscure to map individually.

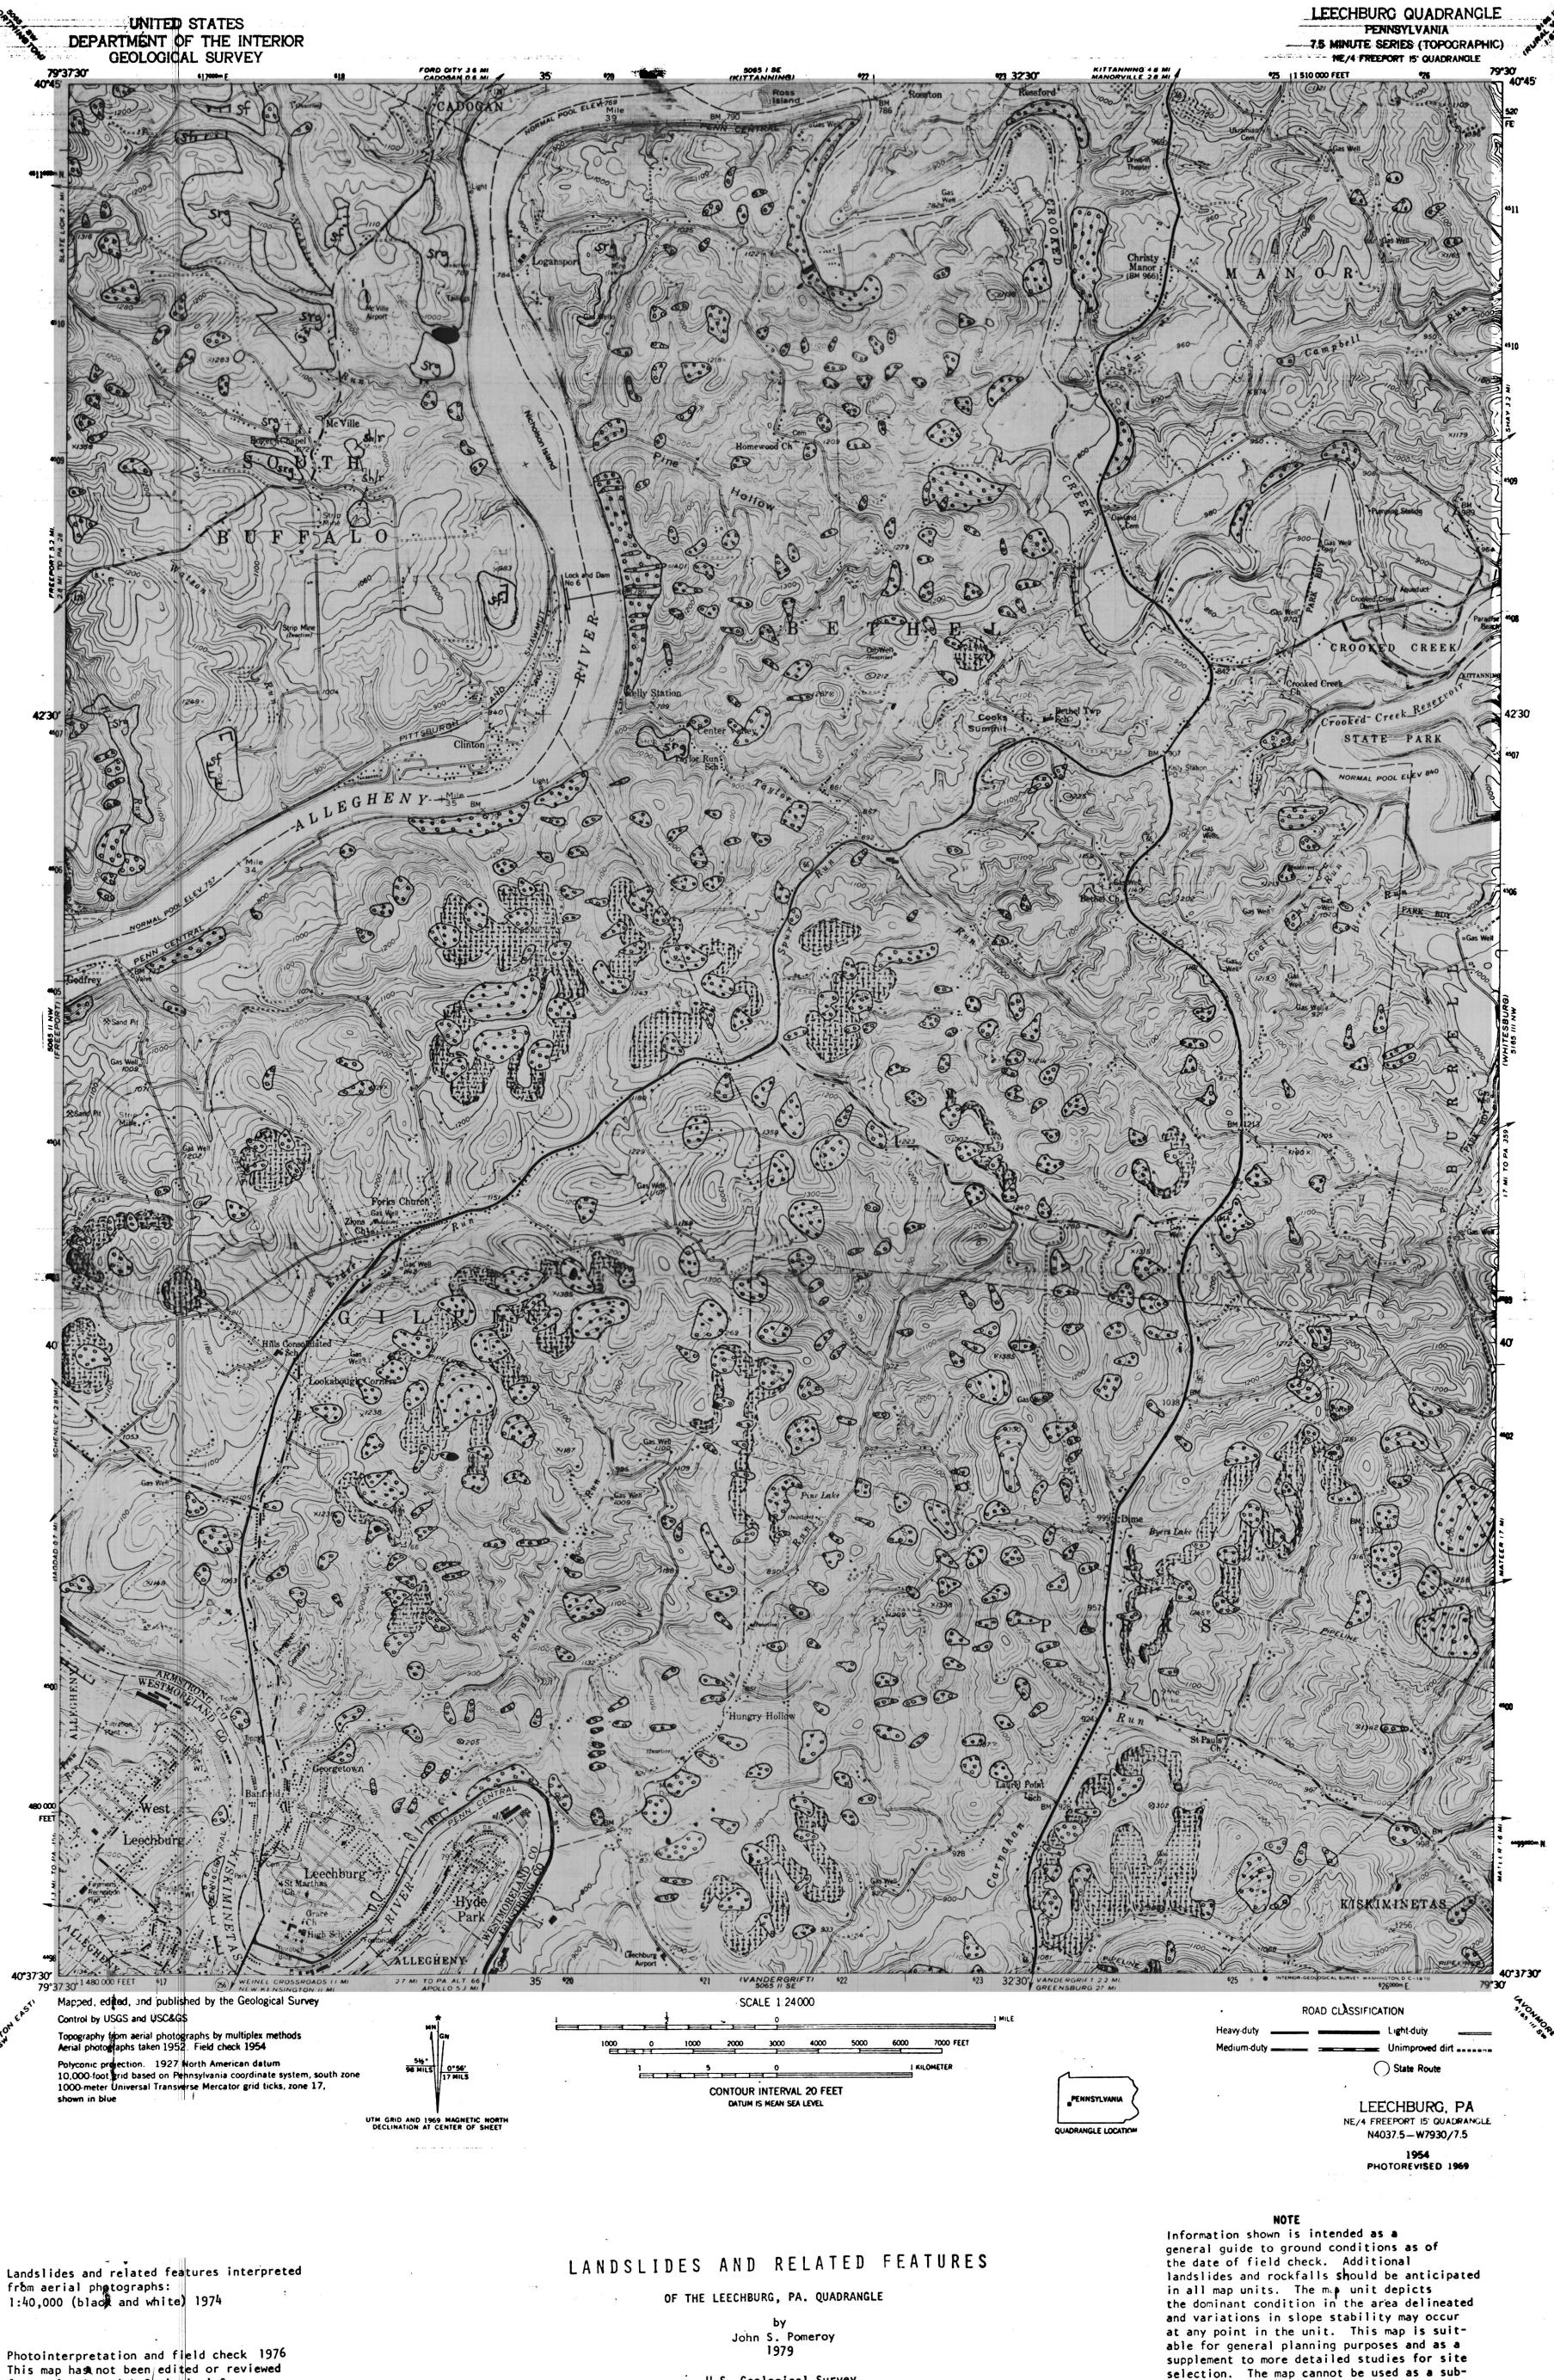
ACTIVE OR RECENTLY ACTIVE LANDSLIDE Complex landslide composed of earthflow, debris. .., slide, earth and rock slump. Identified from historical records, and from scars, dehris and other field evidence. Ground extremely unstable; sliding accelerated by excavation, loading and changes in drainage conditions. May include areas with several active slides too small to be shown separately. Questioned where doubtful.

OLD LANDSLIDE Area of extensive hummocky ground caused by earthflow and earth and rock slump. Lacks clear evidence of active sliding. Relatively stable in natural, undisturbed state, generally not affected by small structures properly sited in areas away from the edge of the toe; can be reactivated by extensive, rapid excavation, loading, and changes in ground water and surface water conditions. Area of old landslide probably includes recent ones not identified from field evidence or otherwise documented. Upslope boundary of landslide generally defined by modified scarp, but downslope (toe) may be gradational and not well defined. Questioned where doubtful.

AREAS SUSCEPTIBLE TO DEBRIS FLOWS AND DEBRIS AVALANCHES Primarily shallow, narrow ravines and chutes with accumulation of stony colluvium generally 10 ft. (3 m) or less in thickness; susceptible to rapid movement during intense rainfall. Most ravines and chutes designated show evidence of former debris flows and avalanches. Symbol & designates historical debris flow or debris avalanche.

AREAS SUSCEPTIBLE TO ROCKFALL Steep, locally vertical, natural and man-made slopes and cliffs, 15 ft. (4.5 m) or more high; formed dominantly of sandstone, limestone, sandy shale, mudstone and claystone. Interbedded mudstone, claystone and shale weather rapidly leaving sandstone and limestone rock faces unsupported.

SOIL AND ROCK SUSCEPTIBLE TO LANDSLIDING Soil and rock similar to that involved in landslides elsewhere in map area; primarily areas underlain by claystone, mudstone and shale associated with other rock types. Rock weathers rapidly on exposure forming clayey soil highly susceptible to sliding. Includes coves (U-shaped, shallow valleys) containing thick layers of clayey soil that are very susceptible to sliding where excavation breaks continuity of slope and where overloaded by artificial fill.

AREAS LEAST PRONE TO LANDSLIDES Map areas in which no patterns or symbols are shown; primarily valley floors, ridge tops and broad benches; modification by excavation and fill may lead to local landslides. Includes slopes where landslides are sparse.
